# Manhole Inspection Summary

Manhole # S35C\_\_047MH

Insp Date: 11/14/08 2:06 PM

**Location** Address: **1 E Franklin St**

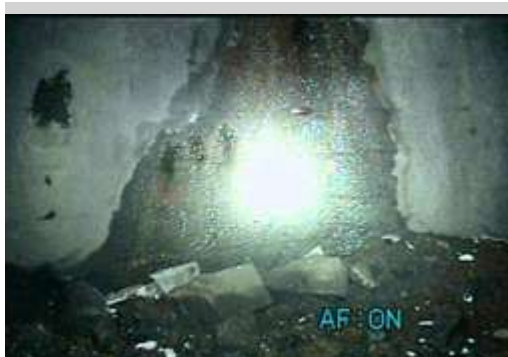
Defect 6

Infiltration: ☐ None ☐ Joint ☐ Cracks ☐ Mortar ☐ Roots ☒ **Wall**

Condition: ☐ Sound ☐ Cracked ☐ Root Intrusion ☐ Deteriorated ☐ Leaks ☒ **Debris**

barrel infiltration, bench debris

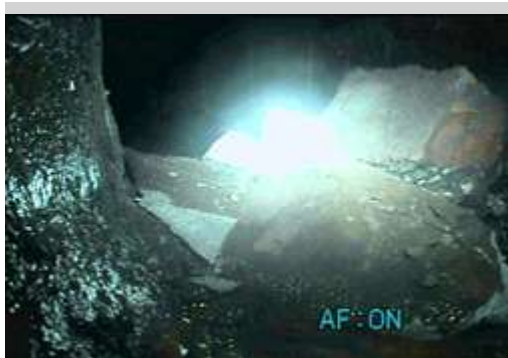
Defect 4

Condition: ☐ Sound ☐ Cracked ☐ Root Intrusion ☐ Deteriorated ☐ Leaks ☒ **Debris**

channel debris

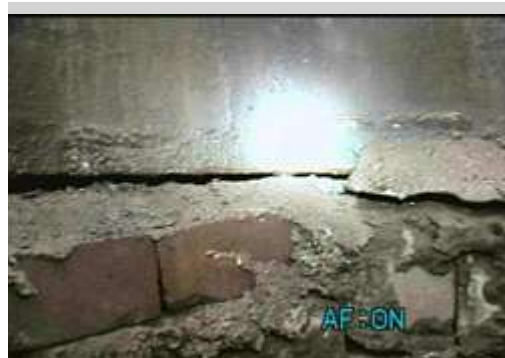
Defect 3

Condition: ☐ Sound ☐ Cracked ☐ Root Intrusion ☐ Loose Brick ☒ **Deteriorated**

Infiltration: ☐ None ☒ **Joint** ☐ Cracks ☐ Mortar ☐ Roots ☒ **Wall**

chimney deteriorated at frame joint,  
infiltration

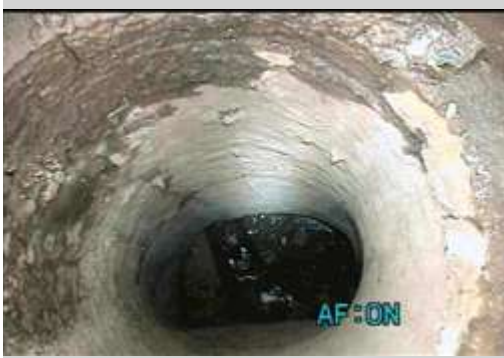
Defect 2

**Steps** Count: **7** Missing: **7** ☒ **Corroded**

chimney deteriorated, infiltration, steps corroded and missing

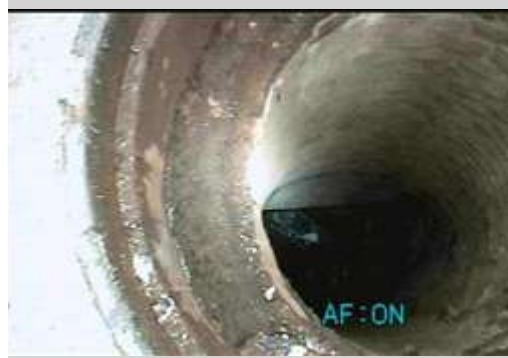
Defect 1

**Frame** Offset: **4** (in.) Condition: ☒ Sound ☐ Cracked ☐ Leaks

offset

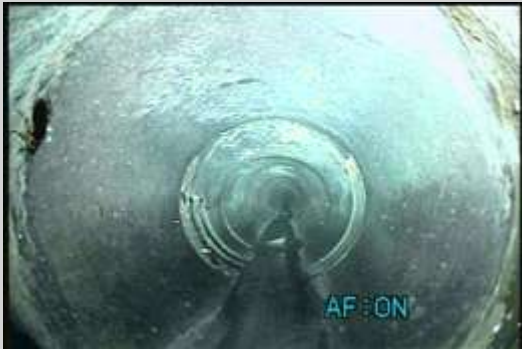
12 O'Clock Outflow

10 in. Circular Gravity Sewer  
Pipe Out @ 12 O'Clock

Pipe Material: **Clay** ☐ Pipe Lined

Invert Depth: 14.41 (ft.) Flow Characteristics: **Slow**

Deposits: ☒ None ☐ Mud ☐ Sludge ☐ Debris ☐ Grease

Infiltration: **None** Pipe Seal Cond: **Unknown**

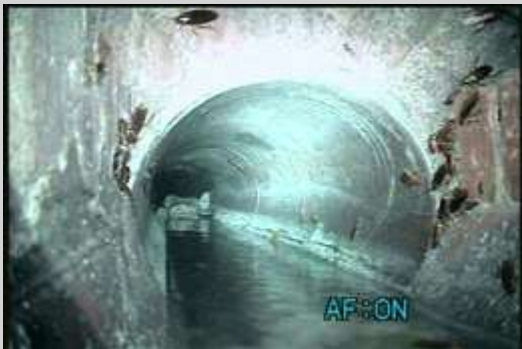
4 O'Clock Inflow

10 in. Circular Gravity Sewer  
Pipe In @ 4 O'Clock

Pipe Material: **Clay** ☐ Pipe Lined

Invert Depth: 13.30 (ft.) Flow Characteristics: **Slow**

Deposits: ☒ None ☐ Mud ☐ Sludge ☐ Debris ☐ Grease

Infiltration: **None** Pipe Seal Cond: **Unknown**
